COST AND PERFORMANCE REPORT

Ultrasonic Guided Wave Technology for Non-invasive Assessment of Corrosion-induced Damage in Piping for Pollution Prevention in DOD Fuel Storage Facilities

ESTCP Project WP-200819

Version 2

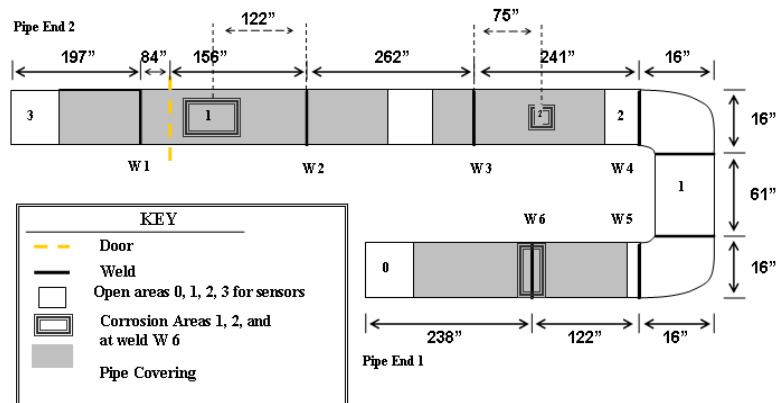
Figure 4. Location of ultrasonic measurement points and corrosion defects in the 8.6 inch diameter pipeline at NSWCCD.

Figure 4 illustrates the locations of the corrosion-induced defects. Two defects (unknown to the inspectors) were placed in the long straight sections of the pipeline. One of the defects not only increased systematically in its depth, but also along the pipe axis and along its circumference as the exposure progressed (Defect 1). The other defect was intended to be a "small" defect (Defect 2) having a fixed lateral dimension of approximately 3 inch x 3 inch, but with increasing material loss in the thickness direction. The goal was to achieve a wall thickness loss exceeding 50% in this defect by the end of Phase I.

In Figure 4 regions 0, 1, 2, and 3 shows where transducers were mounted. We see that waves excited by Sensor 3 propagating in the negative direction should reach Defects 1 and 2 before reaching an elbow. Waves excited by Sensor 2 propagating in the positive direction should reach Defects 2 and 1 before it reaches the pipe end. Waves excited by Sensor 1 should see Defects 2 and 1 after crossing an elbow in the positive direction, and see the Defect W6 in the negative direction after crossing an elbow. Waves excited by Sensor 0 and propagating in the positive direction sees Defect W6 before reaching either elbow and beyond.

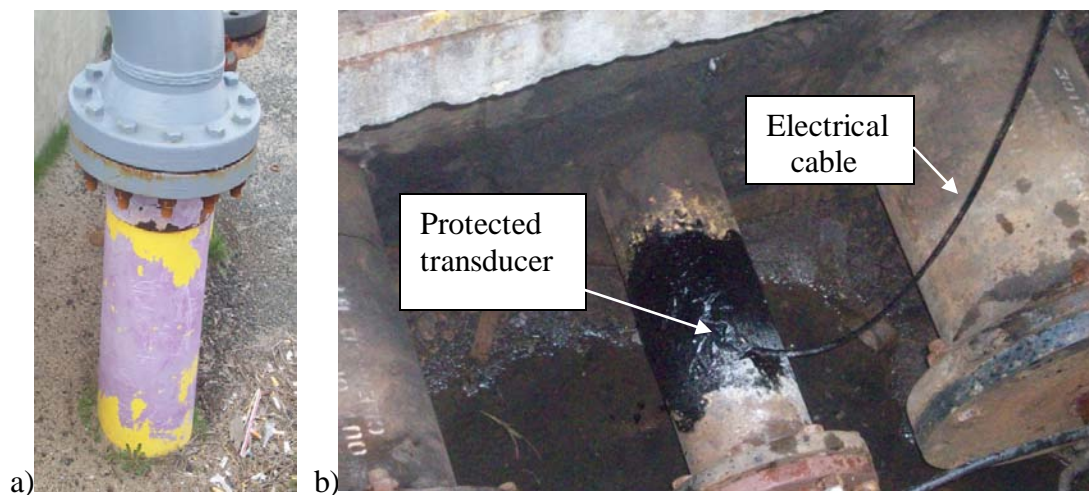
Figure 6. Surface conditions of tested pipe.

6a) Protective paint on a section of pipe to be removed prior to transducer mounting.

6b) Protective tar coating and lead wires for a transducer in the underground pipeline.

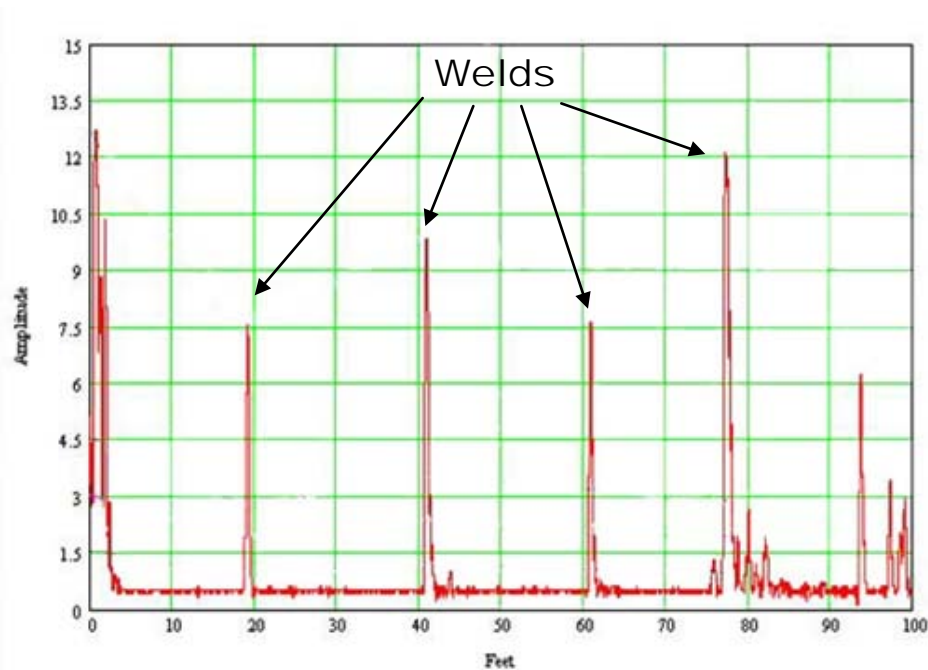
An example of ultrasonic guided wave data showing peak height versus distance along the pipeline (see Figure 4) is shown in Figure 8. Wave propagation speed has been utilized to convert time of flight information to distance information along the pipe. In this figure, the large peaks are reflections from the welds. We note the existence of some small signal peaks with unknown origin before the initiation of corrosion that are not associated with welds. They could

be caused by pipe stands, as-manufactured material anomalies, or other unknown conditions. We will come back to these points later in this report.

Figure 8. Example of plotted ultrasonic guided wave baseline data for the above-ground coating system pipeline at NSWCCD before corrosion was initiated. The plot shows peaks originating from welds, approximately 20 feet apart, as sensed by a transducer mounted in location 2.

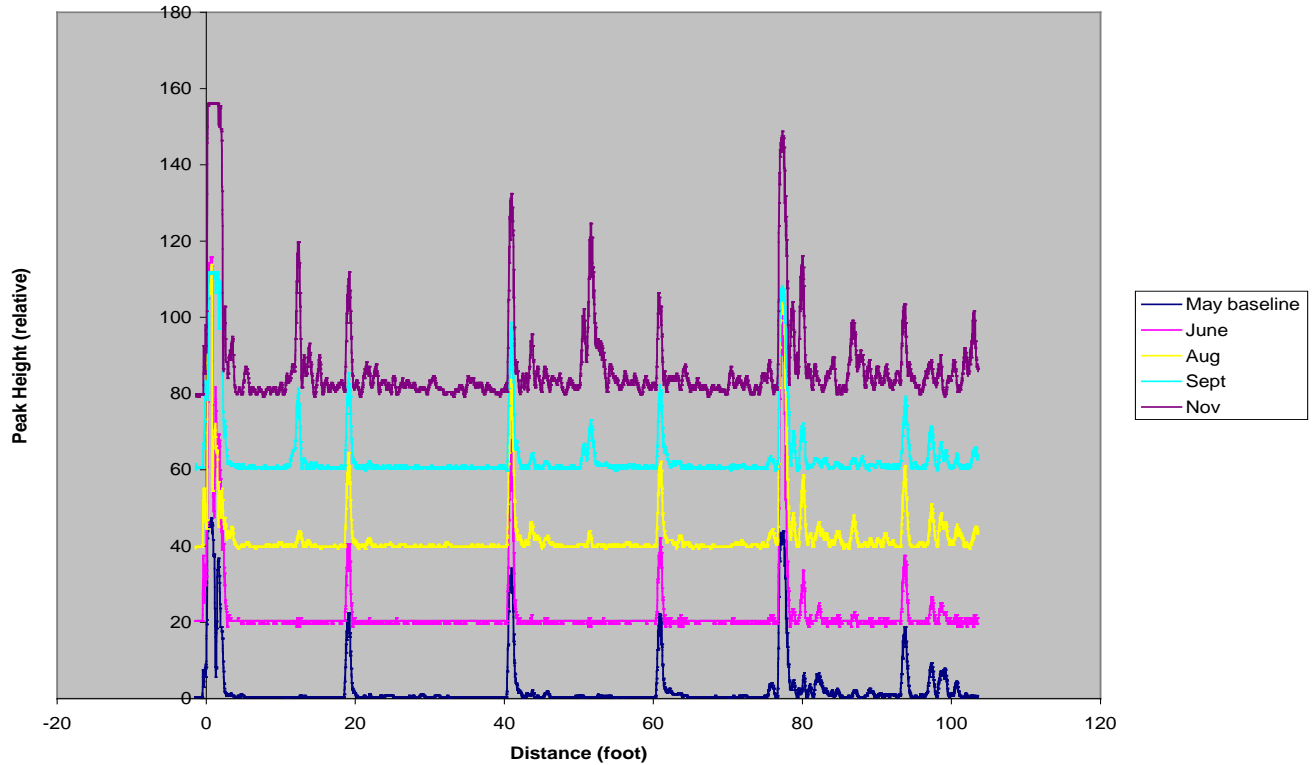
Shown in Figure 9 is the summary of the above-ground ultrasonic wave data over time as compared to the baseline with a systematic increase in defect peak height with successive stages of corrosion from a transducer placed at location 2. Waves from one transducer detect the presence of welds, elbows, and one or more defects in the guided wave propagation path. As expected, the signal height depends on the size of the defect, the distance between the transducer and the defect, and the number of welds in the wave propagation path. We note that the noise level increased in the later months as corrosion progressed, but was less than 0.1 of the weld signal height at about 80 feet.

Figure 9. Systematic increases in defect detection over time as compared to the baseline. Systematic increases in peak heights for growing Defects 1 and 2 sensed by transducer at location 2. Defect 1 was located at approximately 50 feet and Defect 2 was located at approximately 12 feet. The other large peaks, approximately 20 feet apart, are from the welds in the pipeline. The baseline signal (May 2008) is blue, the June signal is pink, the August signal is yellow, the September signal is light blue, and the November signal is purple. An offset of twenty units along the vertical axis has been added to each successive trace before plotting.

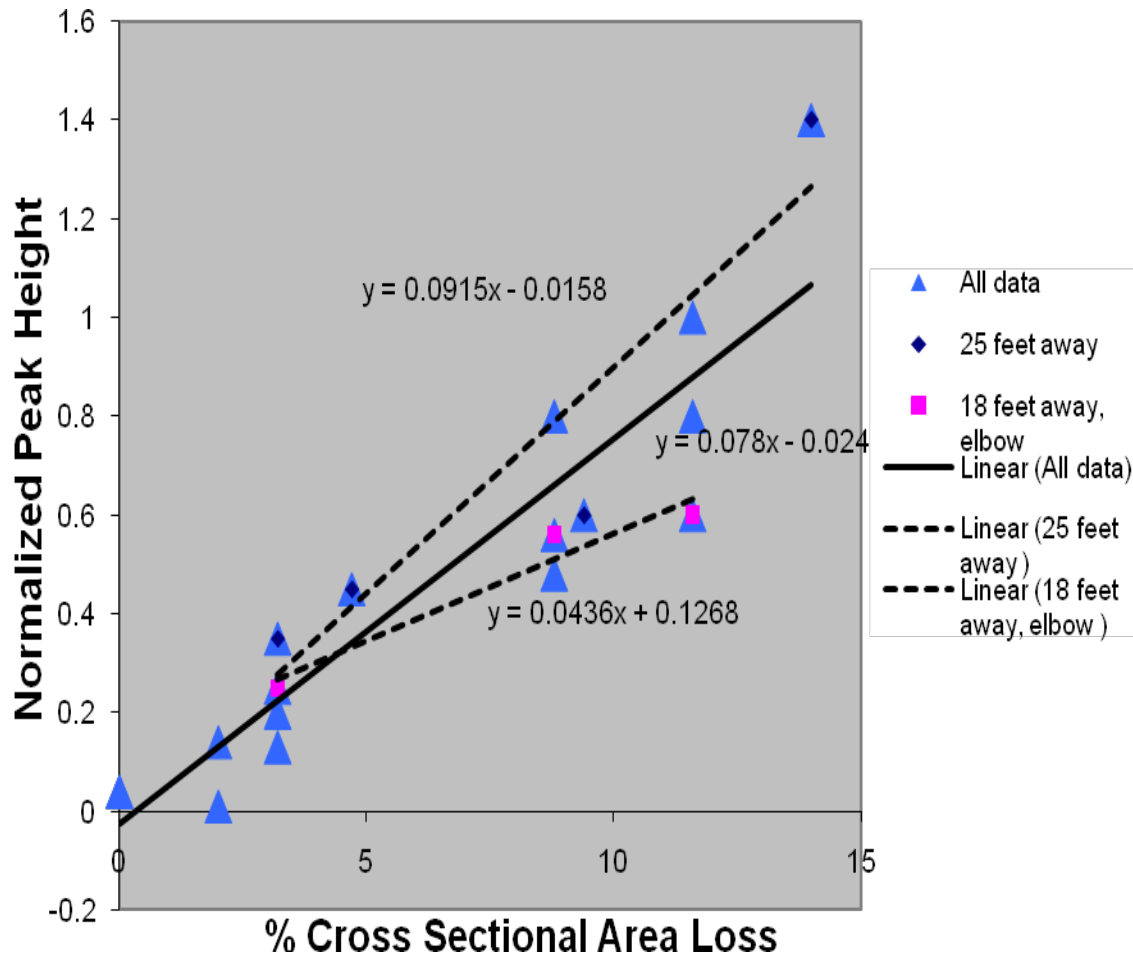
Three trend lines are shown in Figure 10 to summarize the Phase I results. The solid line is based on all the data obtained in Phase I. It represents an averaged trend that provides an empirical “calibration” curve converting relative signal peak height to percentage CSAL for defects. The other two trend lines (dotted) were generated using the two subsets of data including the effects of an elbow (labeled “18 feet away” in the legend) and the ones representing the largest defects (labeled “25 feet away” in the legend). These two dotted trend lines provide the upper and lower bounds for the slope of the average trend line. Defects with 5% and 10% CSAL produced signal peak height of 0.35 and 0.65 volts, respectively, on the average trend line with uncertainties of approximately 25%. These uncertainties are the results of combining all the data obtained from different transducers, located at distances from 12 to 62 feet from the defect, the existence of a variable number of welds and an elbow, as well as defects of different area, volume, and shape.

Figure 10. Trend lines for the increase in signal height as the CSAL increases for data obtained in Phase I.

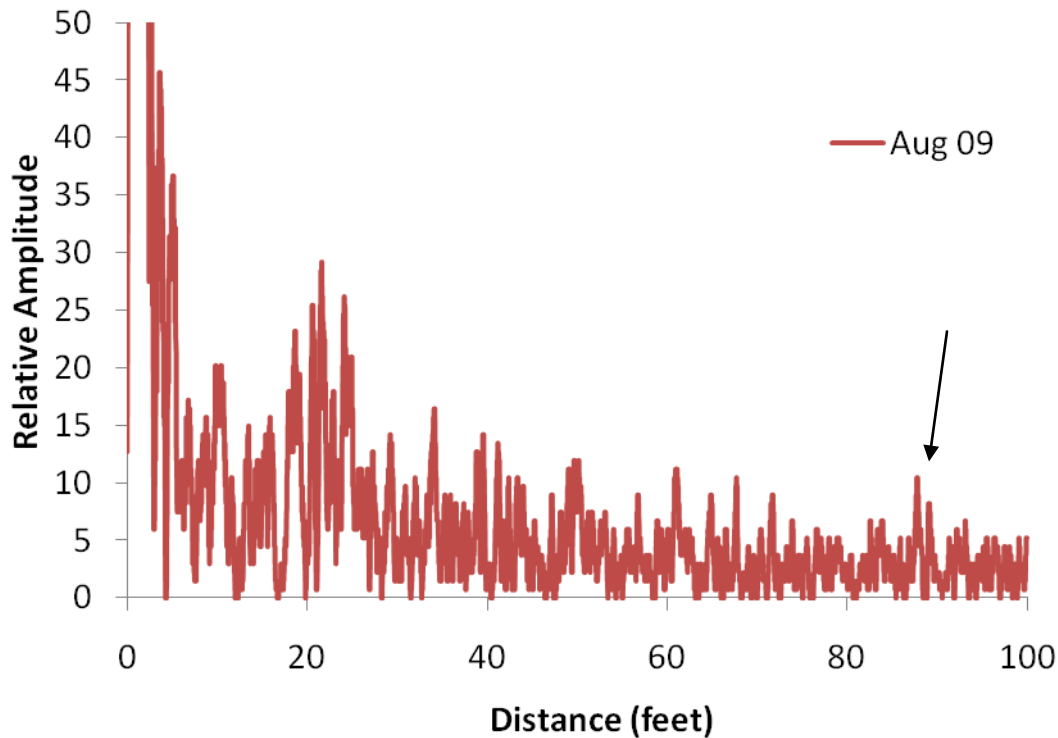
Figure 11. Signal trace at baseline obtained by sensor #22532 inside VP 21 propagating guided waves towards BL 20.

Shown in Figure 11 is the baseline trace for wave propagation from VP 21 towards BL 20. The peaks located up to 20 feet represent signals, first from the leakage of the transducer excitation, followed successively by the signals at the wall interface, and from welds and reducers along the pipeline. Of note is the pair of peaks above noise level at about 90 feet, which could be identified to originate from the region on the ground where pipe repair and replacement were made a few years back. The height of these two peaks was approximately twice as large as the noise level, which was 4 times as large as that typically observed in the laboratory tests in Phase I.

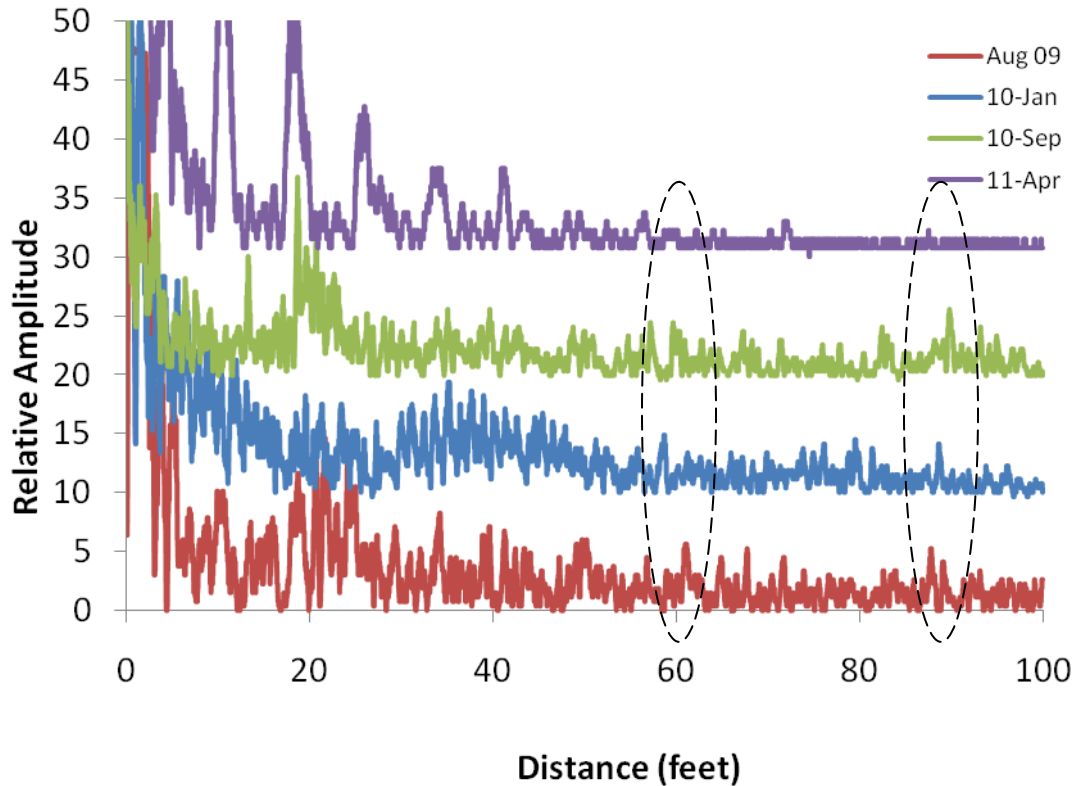
Figure 12. Monitoring changes in data sets obtained at the baseline and successive months by underground sensor #22532.
An offset of ten units along the vertical axis has been added to each successive trace before plotting.

In Figure 12, the data traces collected by an underground sensor (#22532) from the baseline in August 2009 through January 2010, September 2010, and April 2011 are stacked up (with an offset of 10 units on the vertical axis) to facilitate a comparison of the stability in the peaks detected throughout the course of this project. In particular, the pair of peaks around 90 feet pointed at in Figure 12 appeared to be consistently located to within ± 2 feet over the course of 20 months of monitoring. A group of peaks around 60-62 feet appear to be consistently present also.

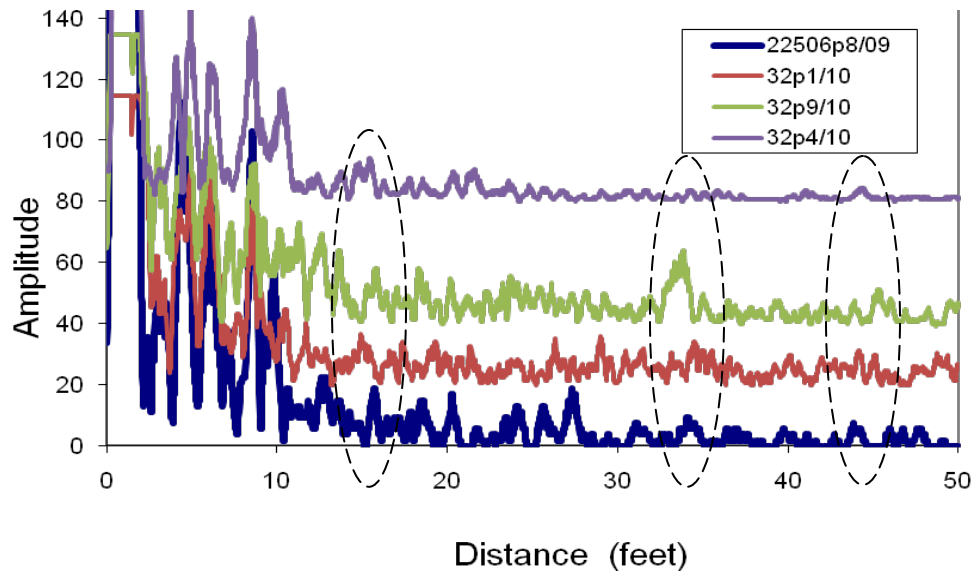
Data traces in Figure 13 are for waves propagating from VP 5 towards VP 20 from sensor #22506. Focusing on the groups of peaks around 16 feet, 35 feet, and 44 feet, we observe that the normalized peak heights at some locations (e.g. 35 feet) have not been increasing consistently or they remained relatively unchanged over the course of the monitoring effort. The locations where peak heights remained constant most likely originated from static structural features such as welds. Inconsistent changes in peak heights could be due to signal noise and/or multiple reflections unrelated to defects.

Figure 13. Monitoring signal changes in data sets obtained by above-ground sensor #22506. An offset of twenty units along the vertical axis has been added to each successive trace before plotting.

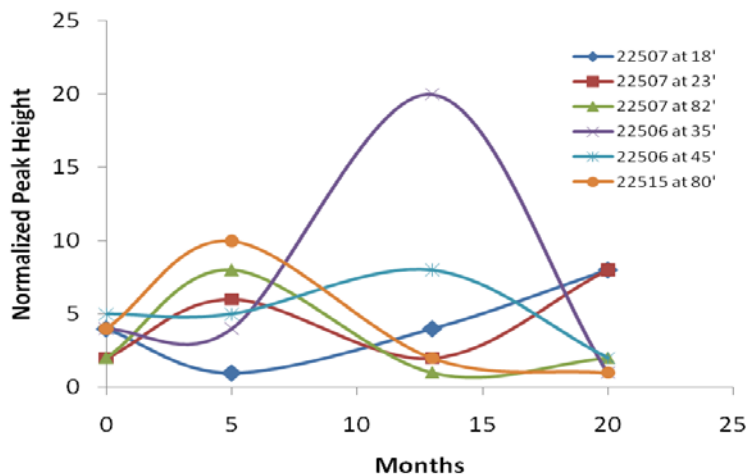
The results of the experiment in Phase I are shown in Figure 14. We observed that none of these peaks increased systematically in amplitude during the 20 months of monitoring. Thus, further monitoring is required to determine whether these locations have corrosion-induced defect growth.

Figure 14. Changes in normalized peak height at suspected defect locations detected by three above-ground transducers. Typical signal noise was 2 vertical units.
